MR imaging of breast implants: Useful information for the interpreting radiologist

James F. Wiedenhoefer, MD, FACOG; Hassan Shahid, MD; Carol Dornbluth, MD; Pamela Otto, MD; and Kenneth Kist, MD

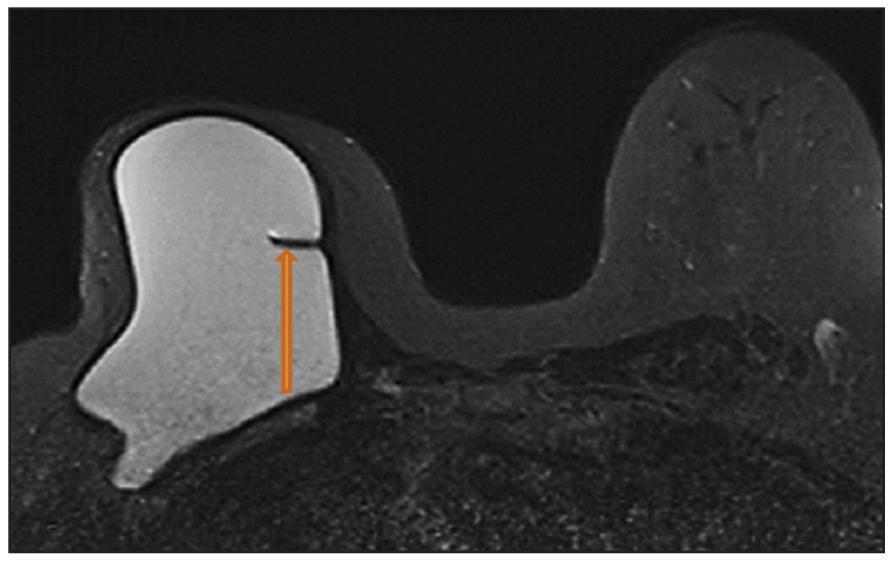
FIGURE 1. A 49-year-old woman with h/o right breast cancer treated with mastectomy and unilateral implant reconstruction. Axial STIR image demonstrates a radial fold (orange arrow) at the medial aspect of the intact right breast silicone implant.

Radial folds, as shown in Figure 1, or shell invaginations, are one of the most common causes for false positive findings on MRI for implant shell rupture. On close inspection silicone should be retained within the implant. Radial folds and periprosthetic fluid should be considered variations of normal following breast implant placement. Radial folds are also commonly found with capsular contraction and subsequent reduction of the surgical bed volume. With violation of the capsule or overlying musculature (subpectoral implants), herniation of the implant into the adjacent parenchyma can occur and result in a contour deformity without necessary implant rupture.

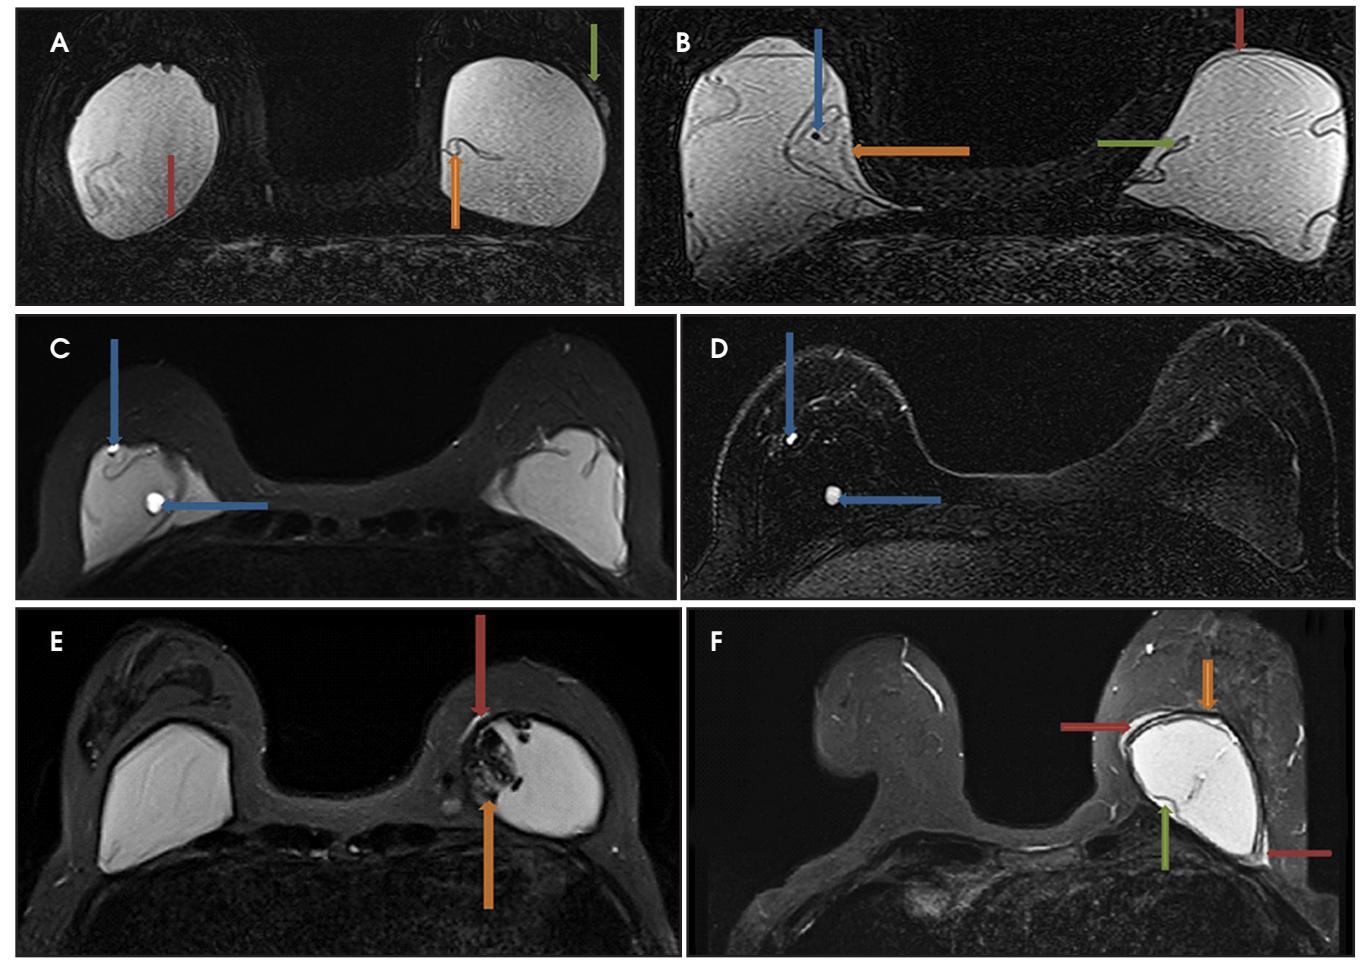
FIGURE 2. Depictions of definitive implant rupture. (A) A 61-year-old woman with palpable left breast mass and 20 year-old silicone implants. She underwent MRI after equivocal findings for rupture on mammogram and sonogram. Axial silicone selective sequence demonstrates a radial fold in the medial aspect of the left breast implant but increased signal intensity (orange arrow) is present between the two leaves of the elastomer shell, consistent with extraluminal silicone, an intracapsular rupture. Additionally, there is increased signal intensity in the extracapsular anterolateral aspect of the left breast (green arrow), adjacent to the implant, which corresponded with her palpable complaint and is consistent with extracapsular rupture. A subcapsular line sign is noted at the posteromedial right breast implant (red arrow). (B) A 50-year-old woman with 13-year-old silicone implants being evaluated for possible rupture. Silicone sensitive sequence demonstrates multiple findings indicative of intracapsular rupture: Linguine sign – right breast (orange arrow), water droplet sign – dark round spots in the right breast implant (blue arrow), subcapsular line sign – anterior left breast implant (red arrow), keyhole/noose sign – medial and lateral left breast implant (green arrow). (C,D). Increased signal intensity within the right breast implant on the axial STIR sequence and axial T2 is consistent with water droplets (blue arrows) within the right breast implant. (E) A 54-year-old woman with MRI for implant rupture evaluation. Silicone-selective sequence demonstrates intracapsular and extracapsular rupture with extracapsular silicone (red arrow) and "salad oil" sign (orange arrow) with high-signal intensity silicone mixing with low-signal intensity body fluids in the medial aspect of the left breast implant. (F) A 62-year-old woman with contour abnormalities of breast implants on screening mammogram. The left breast axial STIR images demonstrate intracapsular and extracapsular rupture with hypointensity of the calcified fibrous capsule (orange arrow) and increased signal intensity from silicone within the capsule (green arrow) and the extracapsular soft tissues (red arrows) of the medial and lateral breast, confirmed on PASTA-SI sequence. The left breast implant also demonstrates subcapsular line sign, consistent with intracapsular rupture.

Signs of definitive implant rupture^{12, 31} (Figures 2A-E)

- Subcapsular lines. These are distinct hypointense lines (bordered by silicone signal intensity on both sides) running parallel to the fibrous capsule but are otherwise contiguous with the implant shell and represent intracapsular rupture.
- Free silicone. This indicates violation or loss of integrity of the capsular shell with extravasation of silicone into the adjacent tissues.
- Linguine sign. Multiple low signal intensity curvilinear lines are present floating within the silicone gel and represent collapse of the silicone elastomer implant shell. As the name implies, these have an appearance similar to linguine noodles.
- Railroad track sign. Paired parallel subcapsular lines in the silicone gel.

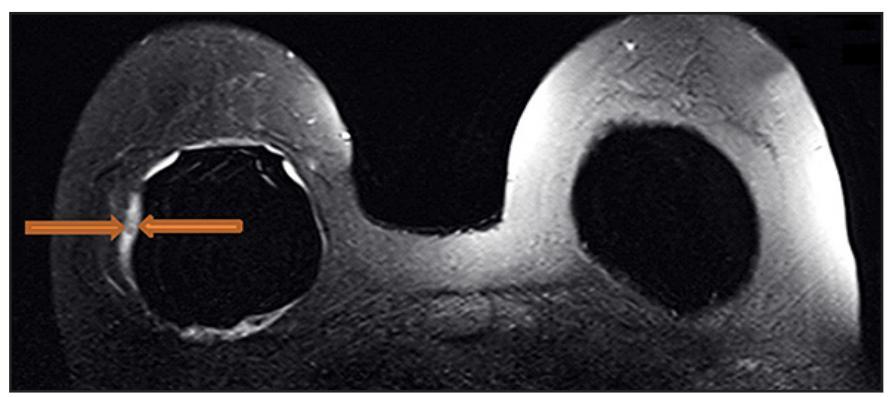
FIGURE 3. A 57-year-old woman with right breast pain with silicone implants. Axial T2 with fat-suppression demonstrates increased T2 signal surrounding the right breast implant and is consistent with periprosthetic fluid.

While peri-implant fluid (Figure 3) can be a physiologic reaction to implantation, consideration of adjacent hematoma or infection should also be considered with additional imaging sequences performed as necessary for further characterization.
